# **INSTALLATION INSTRUCTIONS**

**DESCRIPTION:** Splash Guard Kit - Rear Set

**APPLICATION:** Altima

**PART NUMBER:** T99J2 6CAxx (xx Designates color)

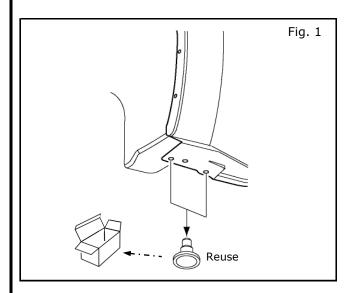
1) Remove clips from rear bumper and keep to reuse.

2) Pull out on bottom corner of rear bumper, and drill 6mm(1/4") holes at dimple locations.

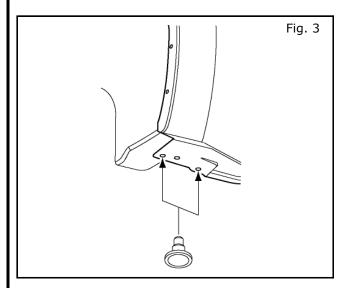
3) Reinstall clips.

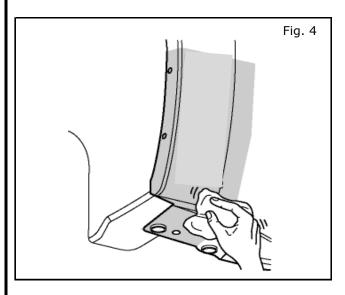
- 4) Clean installation surface (shaded area) with mild soap/water mixture.
- 5) Using a clean, lint free cloth, wipe tape area with 90% or greater alcohol.

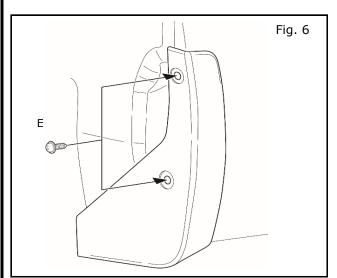
6) Install spring nuts(F).

7) Align rear splash guard to vehicle and loosely install phillips screws(E).

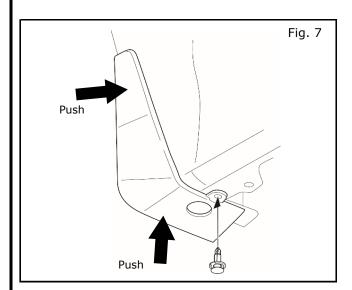
8) Push splash guard upward/inward and install clip(G).

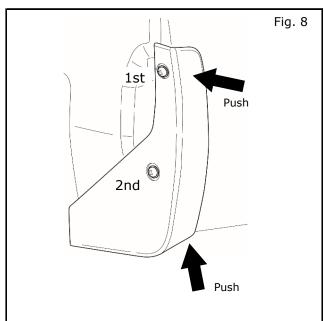
9) Push splash guard upward/inward, and tighten phillips screw(E) in sequence shown.

Do not over tighten screws. Reference tightening torque 3.8~4.4 N-m (33.6~38.9 lb-in).
